Seismic Rehabilitation of an Ancient Masonry Infill Steel Frame Building

ABSTRACT

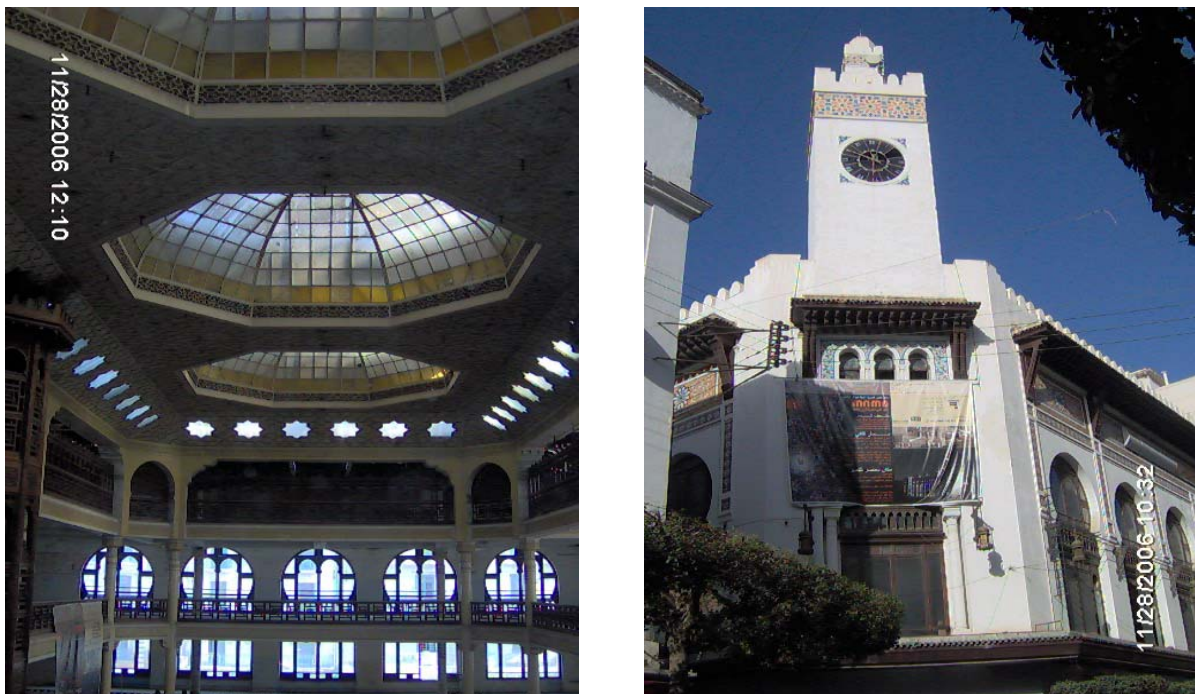
Figure 1. Interior and exterior views of the building.

The edifice is an ancient building constructed in 1909 and intended to be used as a modern art museum. The construction is an L shaped four storey building located in the centre of Algiers. It comprises two patios in the middle with a roof incorporating five domes made of steel frames with glass infill. A 16 m height minaret is located at one corner of the building (Fig. 1).

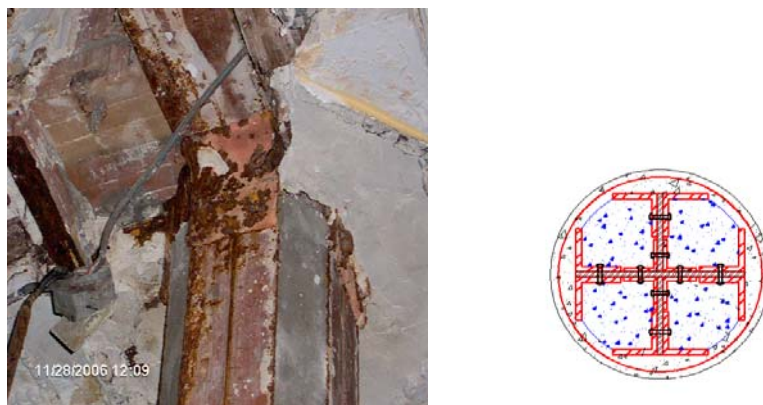
Figure 3 a- Typical steel element corrosion b- column cross section

The slender steel columns are embedded in circular micro concrete sections to enhance their stability performance.

The building withstand several moderate earthquakes that occurred in the vicinity of Algiers and recently a major far field earthquake that occurred in Boumerdes 2003 about 40km away. An investigation of the building was carried out by a multidisciplinary engineering team. Beside the classical tests for material characteristics identification, a special attention was particularly made to investigate the building physically in search of any imprint the earthquakes might have left. The structural damage consists almost exclusively of widespread corrosion observed on certain steel elements because of humidity in areas subjected to water leak and exposed to sea environment. (Fig. 3).

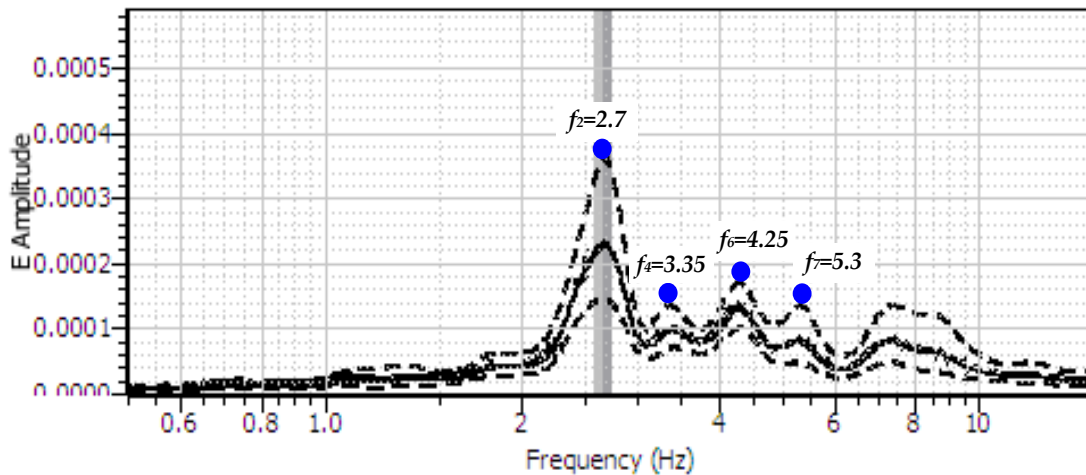
Figure 6. FRF curve recorded on point 5.

The first few lower frequencies were identified (Table 1) and representative FRF curves are shown in Figs. 5 and 6. The continuous lines represent the average curves and the dashed lines are the limits of standard deviations.
